Late Fragmentation of Coronary Sinus Lead and Perforation with Retained Guide Wire after Cardiac Resynchronization Therapy

Aman Makhija*,
Arun Mohanty and
Raja Ram Mantri

Department of Cardiology, Sir Ganga Ram Hospital, Rajinder Nagar, New Delhi, India

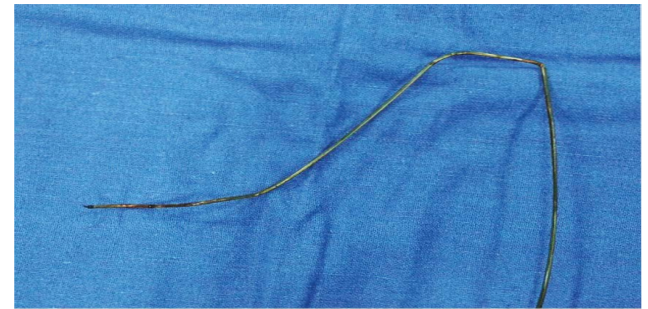
Figure 2 Extracted left ventricular lead with guide wire shows fracture at multiple sites.

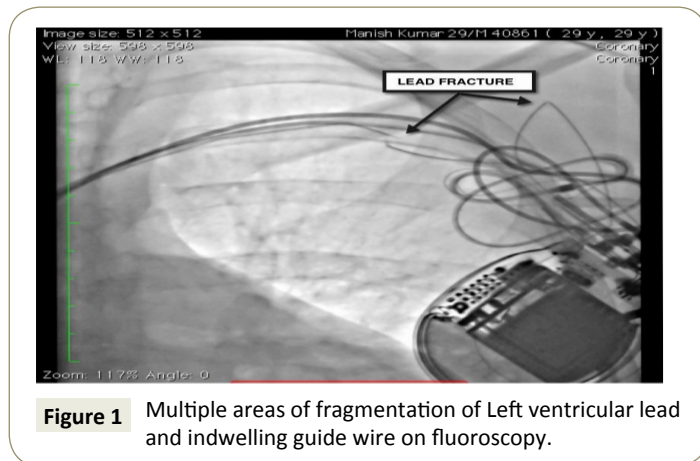
9 months and the other at 12 months post implantation. Device interrogation showed marked rise in LV lead impedance with loss of capture. Fluoroscopy revealed multiple sites of fragmentation in both the coronary sinus lead as well as the indwelling guide wire (**Figure 1**). In one patient, the proximal hard end of the guide wire perforated through the lead, subcutaneous tissue, and the overlying skin. Both these leads were subsequently extracted (**Figure 2**).

Coronary angioplasty guide wires are not manufactured to resist the permanent mechanical stress, especially in the sub clavicular region. Taking into consideration that the guide wire is less flexible than the electrode, it is possible that this may break due to the repeated movements of the patients, which may damage the insulating layers and the spirals of the electrode. Given our experience, one should consider prophylactic replacement of leads already implanted by this technique.

Figure 1 Multiple areas of fragmentation of Left ventricular lead and indwelling guide wire on fluoroscopy.

The retained guide wire not only causes lead degradation but also can cause perforation as was seen in one of our patients. Guide wire inside a lead is neither durable nor safe and should not be retained.
