Late Fragmentation of Coronary Sinus Lead and Perforation with Retained Guide Wire after Cardiac Resynchronization Therapy

Aman Makhija*,
Arun Mohanty and
Raja Ram Mantri

Department of Cardiology, Sir Ganga Ram Hospital, Rajinder Nagar, New Delhi, India

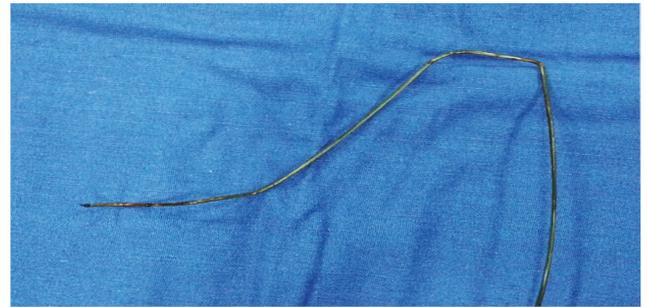
Figure 2 Extracted left ventricular lead with guide wire shows fracture at multiple sites.

Coronary angioplasty guide wires are not manufactured to resist the permanent mechanical stress, especially in the sub clavicular region. Taking into consideration that the guide wire is less flexible than the electrode, it is possible that this may break due to the repeated movements of the patients, which may damage the insulating layers and the spirals of the electrode. Given our experience, one should consider prophylactic replacement of leads already implanted by this technique.

The retained guide wire not only causes lead degradation but also can cause perforation as was seen in one of our patients. Guide wire inside a lead is neither durable nor safe and should not be retained.

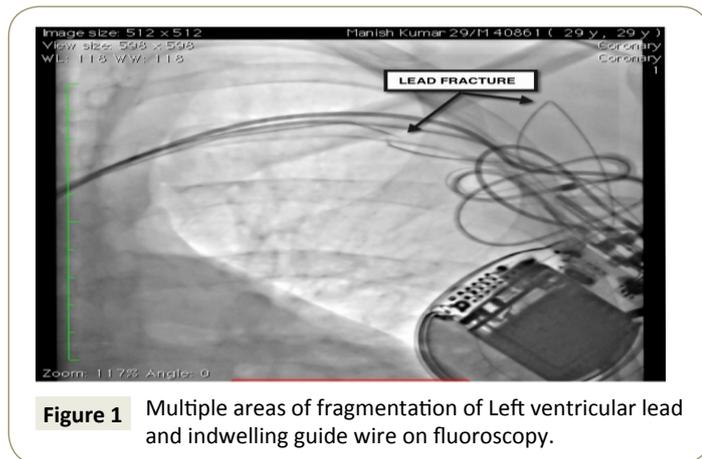
9 months and the other at 12 months post implantation. Device interrogation showed marked rise in LV lead impedance with loss of capture. Fluoroscopy revealed multiple sites of fragmentation in both the coronary sinus lead as well as the indwelling guide wire (**Figure 1**). In one patient, the proximal hard end of the guide wire perforated through the lead, subcutaneous tissue, and the overlying skin. Both these leads were subsequently extracted (**Figure 2**).

Figure 1 Multiple areas of fragmentation of Left ventricular lead and indwelling guide wire on fluoroscopy.
